LOUISIANA DEPARTMENT OF WILDLIFE & FISHERIES

WATERBODY MANAGEMENT PLAN SERIES

HENDERSON LAKE

LAKE HISTORY & MANAGEMENT ISSUES

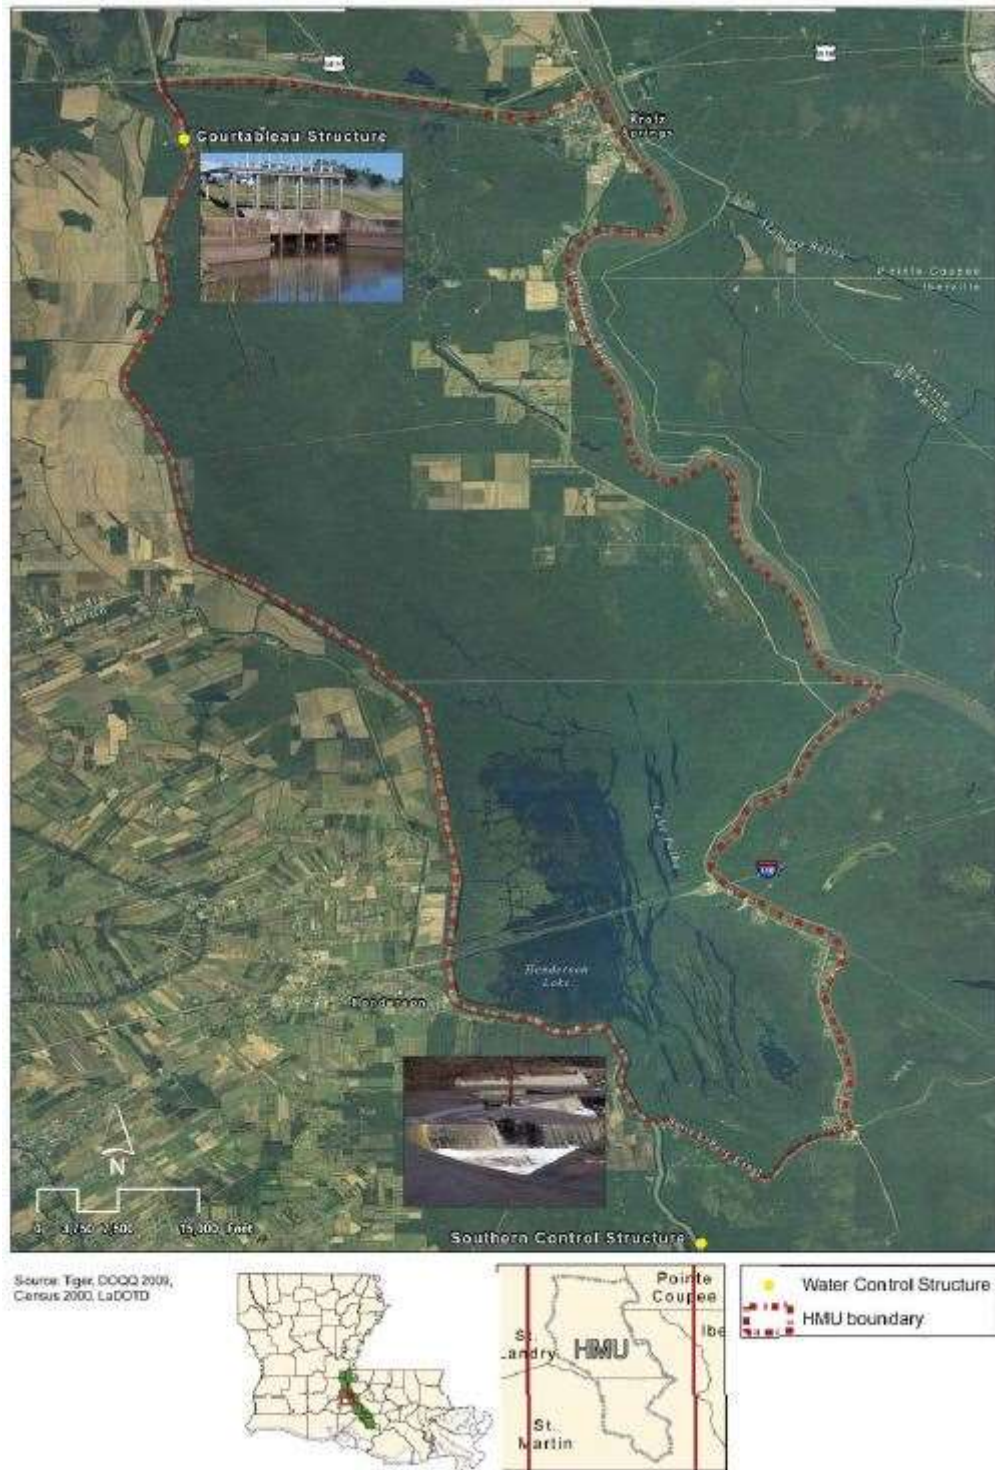
Figure 1. Location of water control structures within Henderson Lake, LA.

The southern control structure is located in St. Martin Parish, south of Henderson Lake in the borrow canal adjacent to the West Atchafalaya Basin Protection Levee (WABPL). The drawdown structure is a gated system that can be opened to allow ingress and egress of boat traffic, and can be used to dewater the lake (see map of structure locations, Figure 1).

At the northern end of Henderson Lake, the Bayou Courtableau structure is owned and operated by the USACE. It is located approximately one mile south of U. S. Highway 190 between Port Barre and Krotz Springs. The structure is made up of two features. A diversion control structure completed in 1942 consisting of two weirs with crests set at 18 feet National Geodetic Vertical Datum (NGVD) that releases water into the borrow canal located on the landside of the WABPL. This diversion is also used to maintain low flows in Bayou Teche and the Vermilion River for rice irrigation and water quality control. During periods of drought, Atchafalaya River water can be pumped in through the Vermilion-Teche pumping station which is owned and operated by the USACE. That water is channeled to the Bayou Courtableau control structure via the Darbonne Bay conveyance channel. In addition, there is the Bayou Courtableau Drainage Structure, in the WABPL that releases landside flood waters into the northern end of Henderson Lake. This structure, consisting of five reinforced concrete box culverts measuring 10 ft. wide by 15 ft. high, and 234 ft. in length, was built by the USACE in 1956. This is one of only two structures that provide entry points for water into the Henderson Lake area other than precipitation. When the Atchafalaya River rises, its backwaters flow northward through the southern control structure, which is the other point of river water entry into the lake. Water entering through the southern structure also has to exit through that same structure. Water flowing into Henderson Lake from the Bayou Courtableau Drainage Structure is often of poor quality due to the high loading of organic materials from agricultural runoff in heavy rainfall and flood conditions.

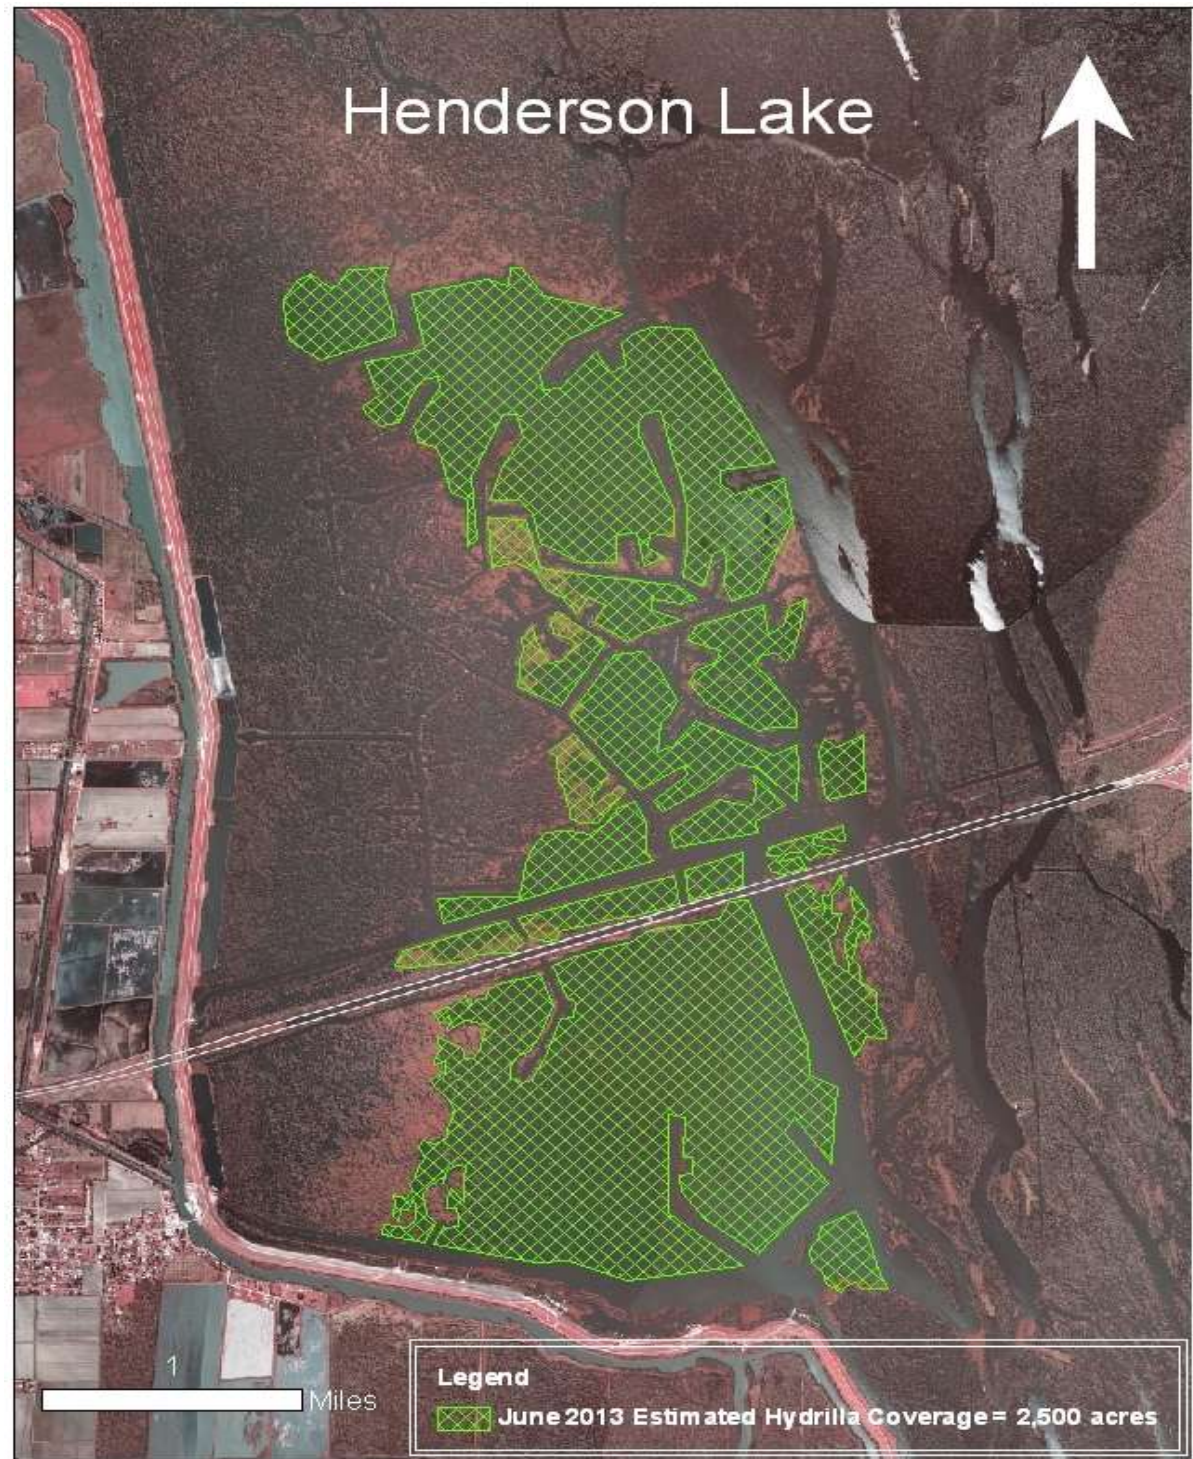
Figure 1. Henderson Lake hydrilla coverage as of June, 2013.

There is an ongoing concern with the infestation of the aquatic plants hydrilla (*Hydrilla verticillata*) and water hyacinth (*Eichhornia crassipes*). Annual requests are received from fishermen, hunters, camp owners, and boat launch operators to clear floating plants (mainly water hyacinth) for boating access. Many requests come from owners of private pay-to-launch boat ramps and tourism businesses. Unfortunately, immediate relief is expected when vegetation is treated. However, the chemical used to control water hyacinth is a systemic herbicide and can take more than a few days to several weeks to completely kill the plants depending on the air temperature. Private boat landings, as well as the public launch at the I-10 Butte La Rose Welcome Center, are often cleared of water hyacinth only to have rafts of new plants block the ramps after changes in wind direction or water levels. During the summer and fall of 2013 and 2014, there was approximately 50% coverage of hydrilla in Henderson Lake (Figure 1). Presently, the coverage is unknown, but it appears to be significantly less than in previous years. By late summer in previous years, the north and south flats would ‘top out’ with hydrilla at the water surface, expanding growth through the entire water column. From 2015-2017, and thus far in 2018, none of the excessive growth has been observed, though small patches of hydrilla were seen in several places in early 2017. Giant salvinia (*Salvinia molesta*) has also recently become another problematic aquatic invasive species in the lake. During the fall and winter of 2015/2016, plant growth expanded from a moderate amount in December to a massive infestation by April (estimate of coverage unknown). Surveys found that the entire flooded northern woods were filled with the plants. This huge increase in giant salvinia was believed to have occurred as the result of high waters earlier than normal in the winter months providing an abundance of inaccessible backwater habitat, along with very mild winter temperatures. Moderate salvinia growth was observed during the fall and winter of 2016/2017. Record low temperatures during the winter of 2017/2018 saw a decline in the abundance of aquatic nuisance vegetation as many plants died from freezing temperatures.

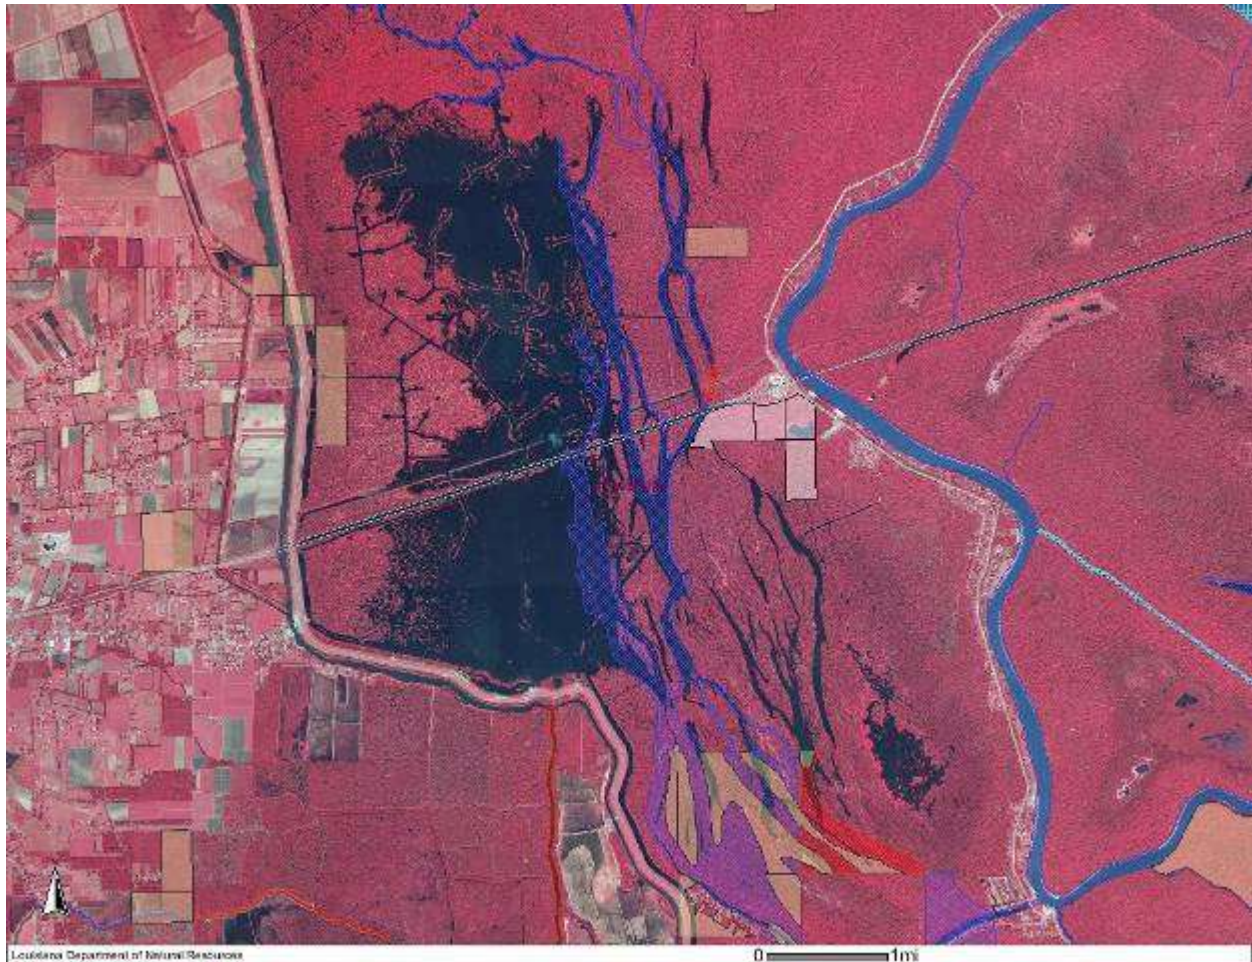
Map of State Water-bottoms in Henderson Lake.

State water-bottoms in blue and state lands in orange and pink outlined in black.

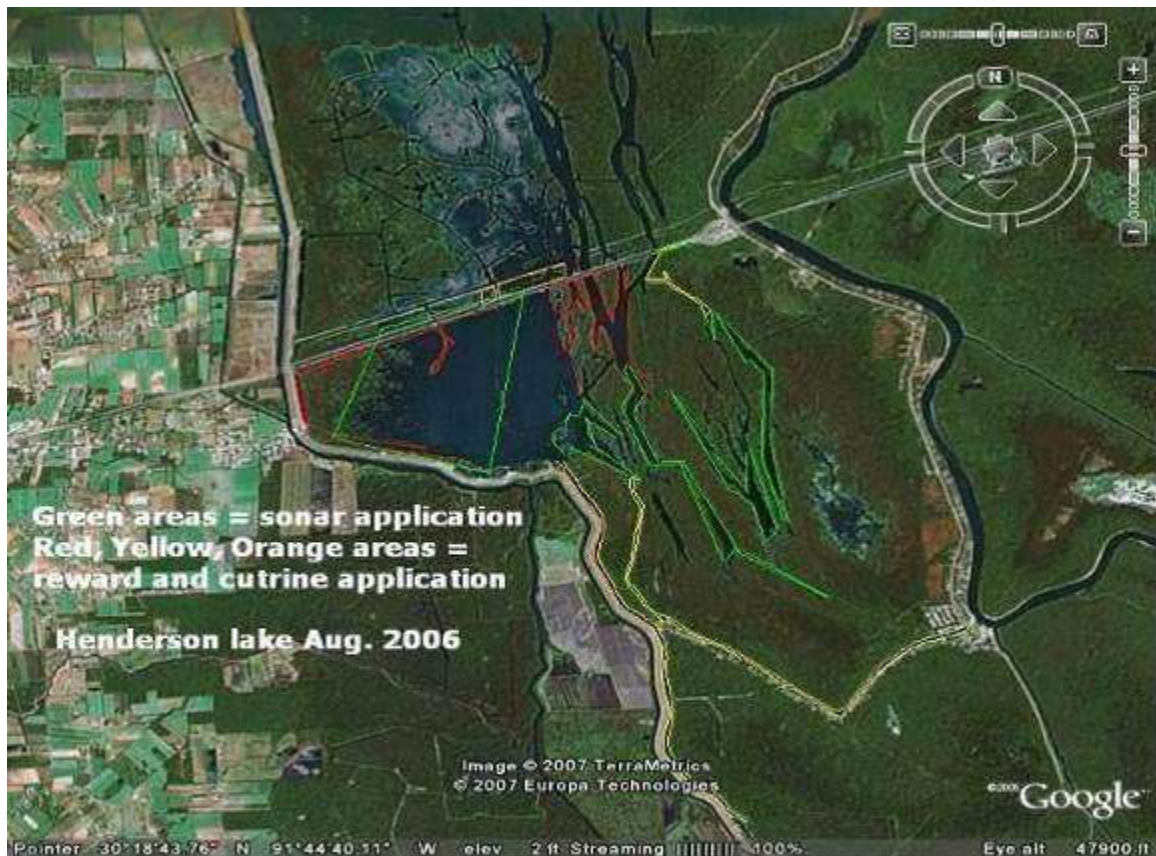
Appendix IV ([click to return](#))

Henderson Lake
September 2006
Jody T. David

Henderson Lake, St. Martin parish, recently (8/28/06) was treated using SONAR to control the heavy infestation of Hydrilla south of interstate 10. Water levels in the lake were lowered two feet below pool stage to allow for adequate control; pool stage is 9.0 ft. (MSL).

Moderate amounts of common salvinia (*Salvinia minima*), coontail (*Ceratophyllum demersum*) and duckweed (*Lemna minor*) were found throughout the lake. Other plants that were observed in light to moderate amounts were primroses (*Ludwigia* spp.), sedge (*Carex* spp.), smartweed (*Polygonum hydropiperoides*), flatsedge (*Cyperus* spp.), and filamentous algae (*Pithophora* spp.) North of interstate 10 a heavy infestation of hydrilla and water hyacinth is present. This includes the north flats, Phillips canal, Coquille Bay and Fordoche Lake and bayou. These areas are Corps owned and were not treated.

Vegetative type map sampling was conducted in the fall of 2003, 2004, 2005, and 2006. The most recent type map is included in [Appendix IV](#).
